**ELLIS ISLAND
STATUE OF LIBERTY NATIONAL MONUMENT**

**HISTORIC STRUCTURES REPORT
UNIT ONE BUILDINGS**

**Volume 2
Part Two**

**Beyer Blinder Belle/
Anderson Notter Finegold**

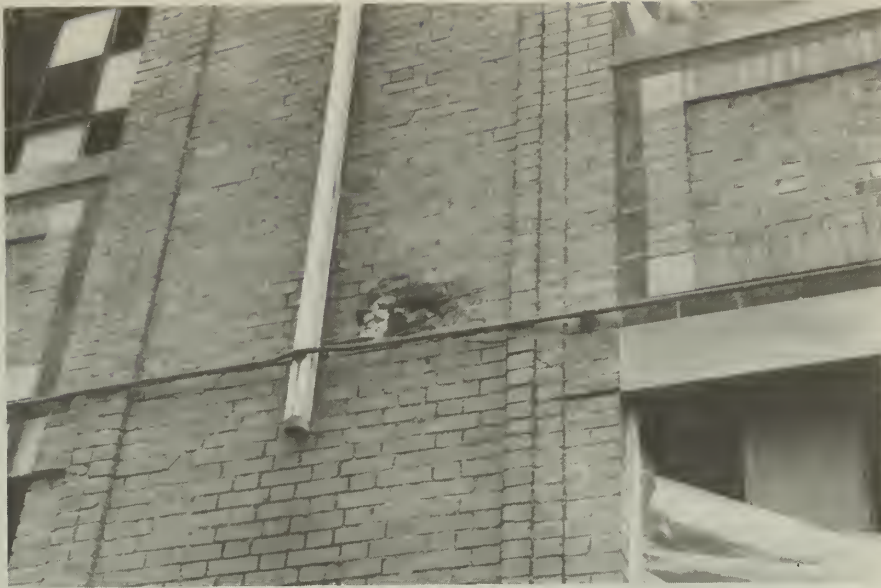
7. Missing downspout and missing brick, west elevation.

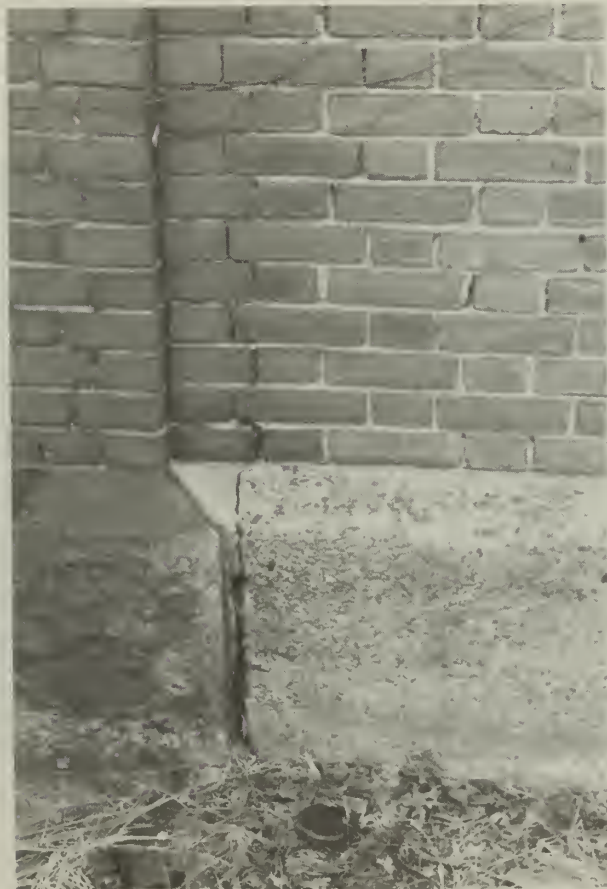
8. Foundation crack at juncture of two-story building with one-story oven room, west elevation.

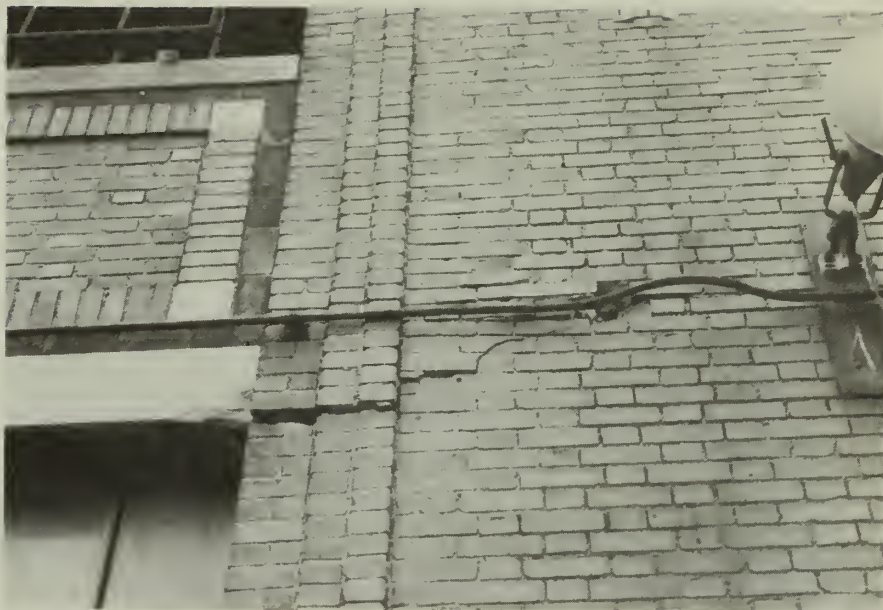
9. Severe cracking at lintel level, west elevation.

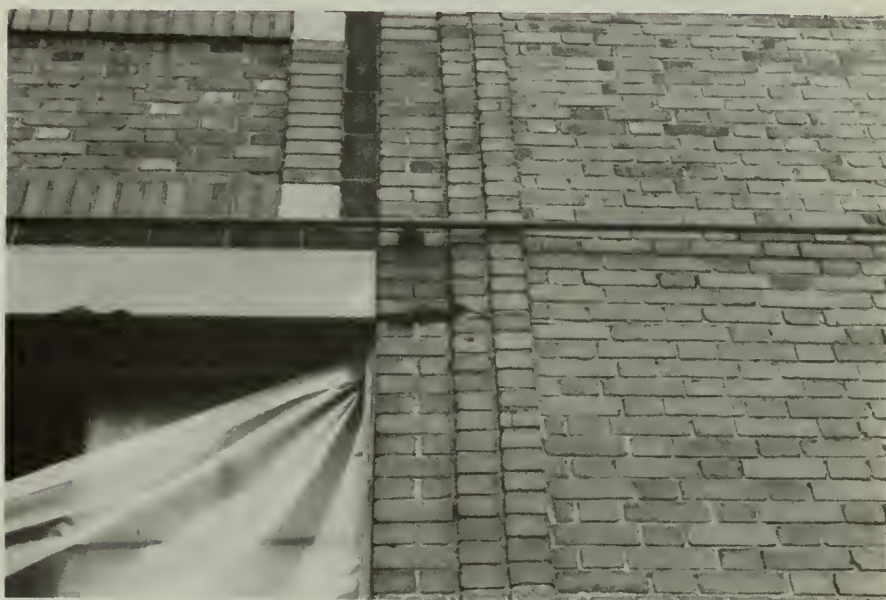
10. Spalling at lintel, west elevation.

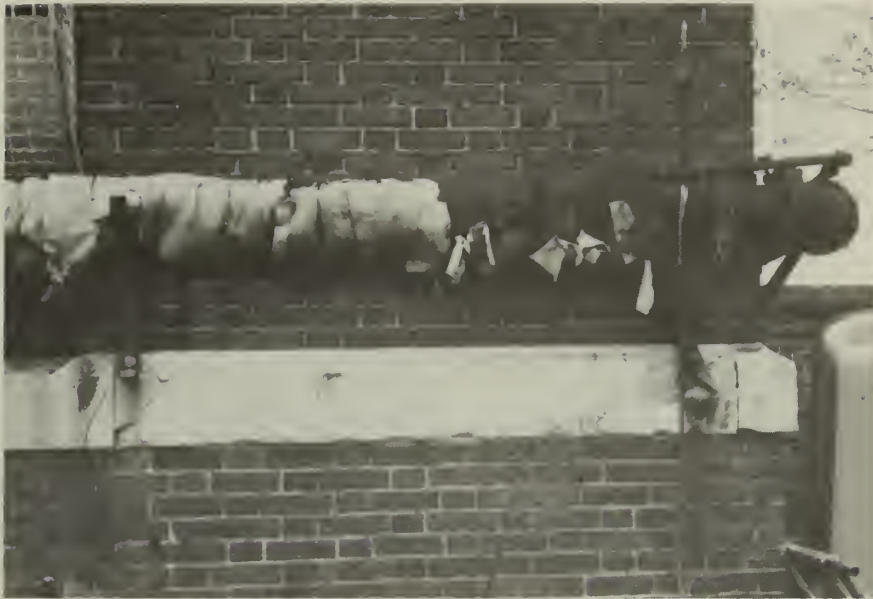
11. Spalling and loss of material at limestone water table due to rusting pipe anchors.

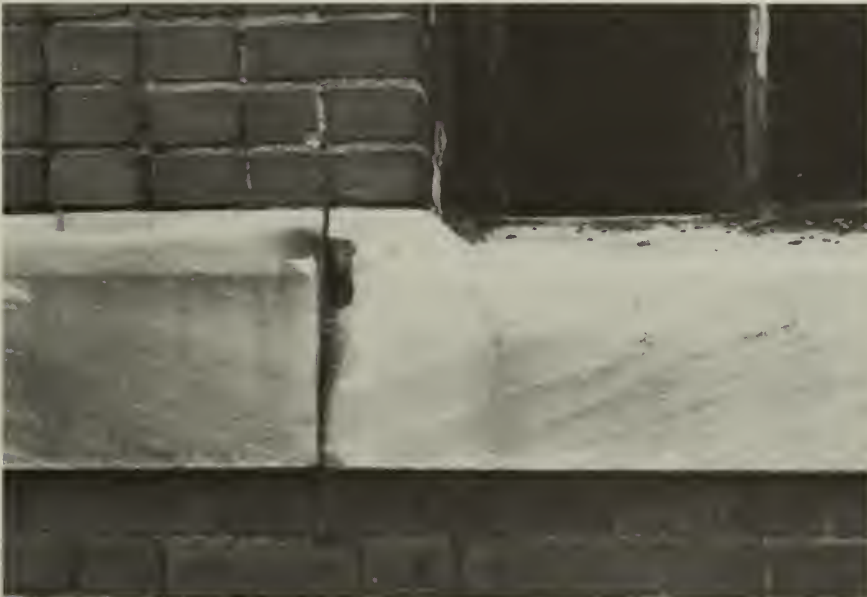
12. Spalling at limestone window sill joints.

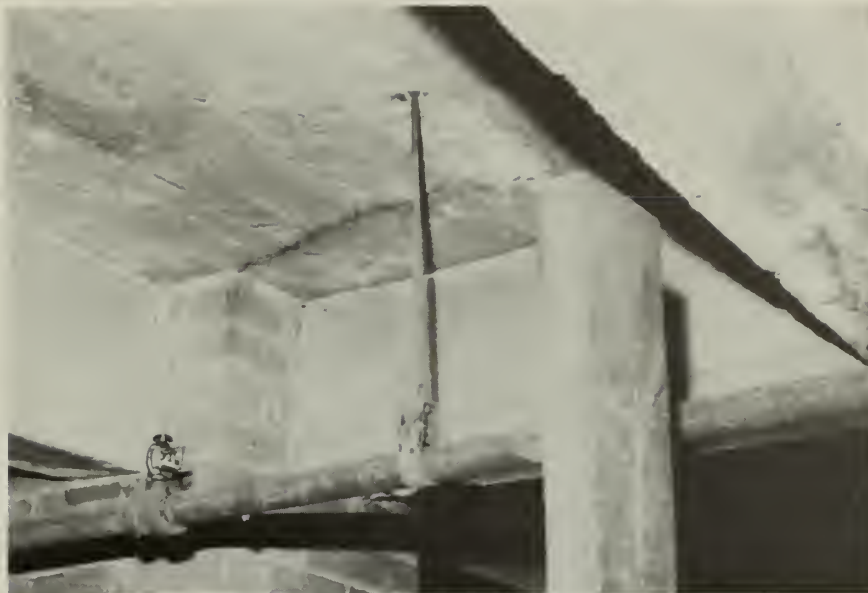
A variety of cracks are found at the underside of the second floor slab (first floor ceiling) in a north-south or east-west direction (photo 1). One of these cracks extends vertically down a west wall. A severe diagonal crack has also occurred on the south wall of room 103. In the one-story bake shop (room 101), structural cracks approximately 1/16" wide appear on the underside of the roof slab running diagonally across the northwest corner (photo 2). Additional roof slab cracks running north-south are severe, with some exposed slab reinforcing. There is a vertical crack in the north wall along the west side of the door (photo 3).

1. Crack in underside of second floor slab.

Cracks occurring in the floor and roof slab have been caused by expansion and contraction of the building and do not constitute unsafe conditions. No remedy is required as they tend to relieve the stresses caused by thermal related movement. Vertical wall cracks should have expansion joint material installed to forestall future cracking.

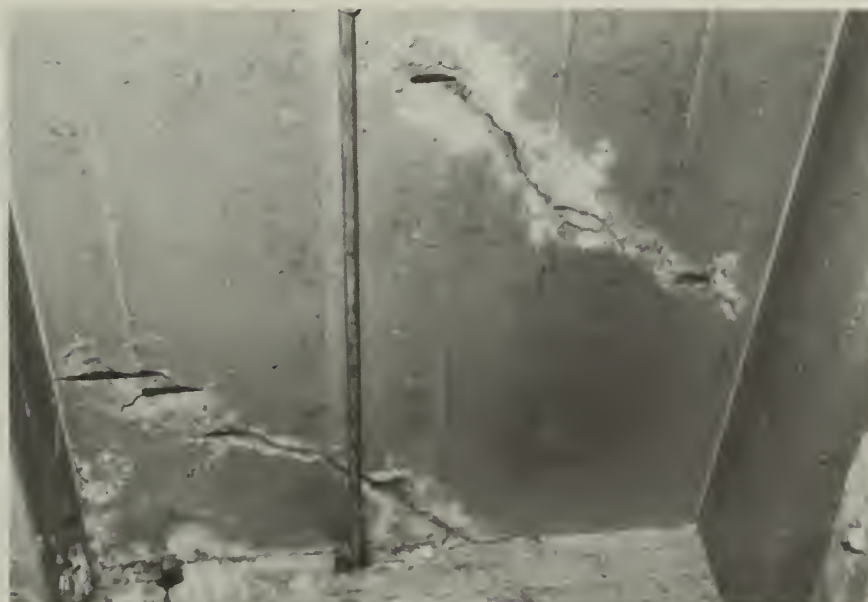
2. Crack at northwest corner of room 101.

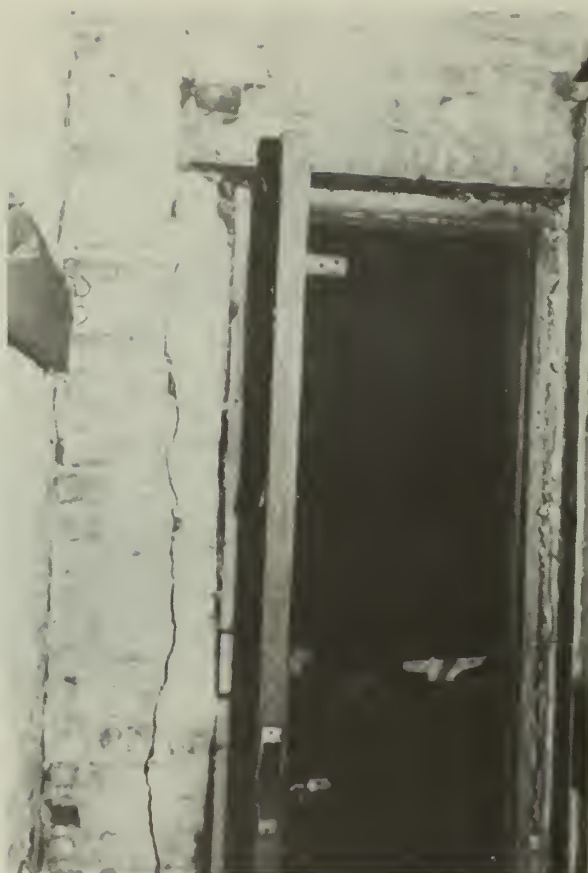
3. Crack along west side of door,
north wall, room 101.

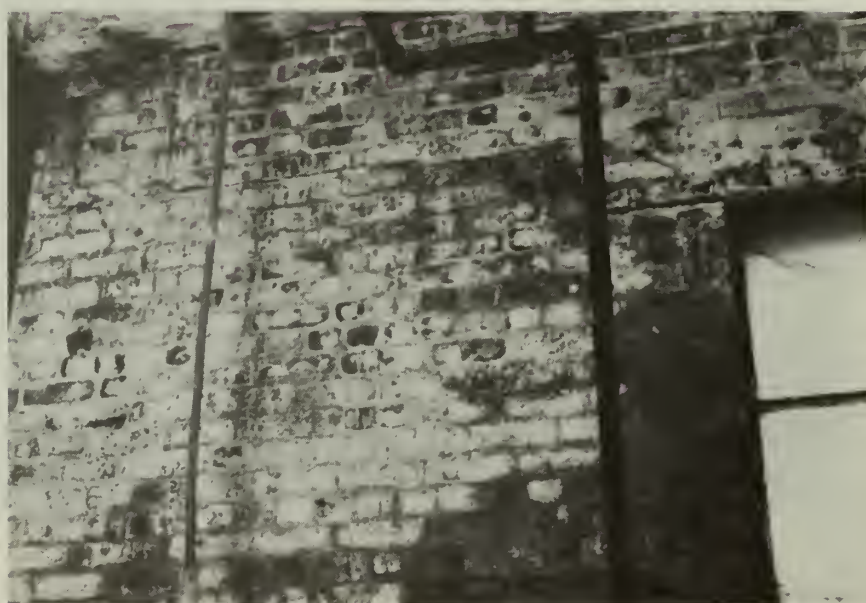
Ceiling cracks occur on the second floor in a similar pattern to those at the first floor ceiling. For the full length of the west wall and at the west end of the north wall horizontal cracking occurs at the level of the window tops (photo 4). The cracks occurring in the floor and roof slab were caused by temperature-related building movement.

4. Crack at level of window tops, west wall, second
floor.

The rusting of beam flanges is causing horizontal wall cracks. Remedial measures include the removal of outside brick, determining the extent of damage and executing necessary reinforcing, cleaning, corrosion proofing and painting.

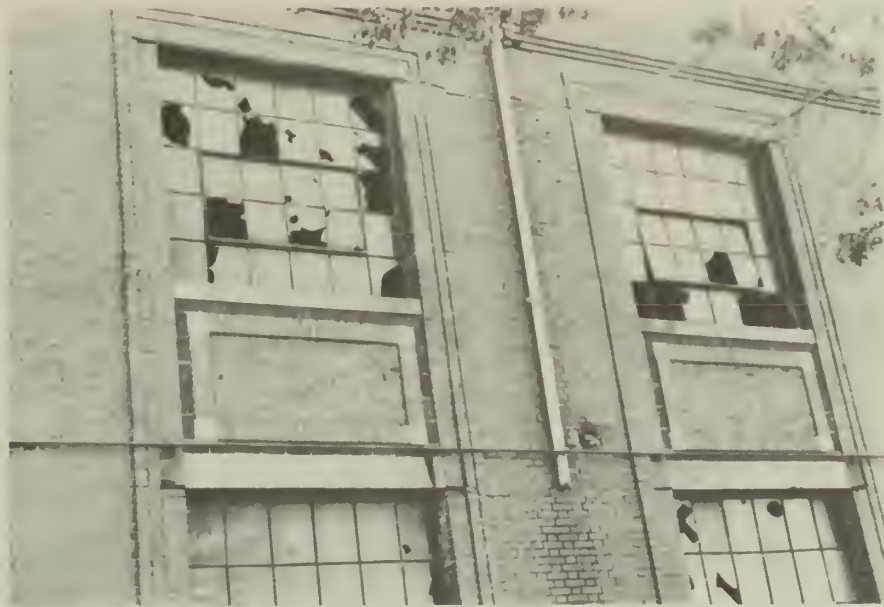
Severe horizontal cracking on the exterior is similar in location and extent to the cracking on the interior walls. Rusting of the flanges of the roof spandrel beams has caused brick to be pushed out at these exterior cracks (photo 5). In addition, a diagonal crack was found where the north wall joins covered way 5 near the powerhouse (photo 6).

5. Brick pushed out at crack along second floor window tops, west elevation.

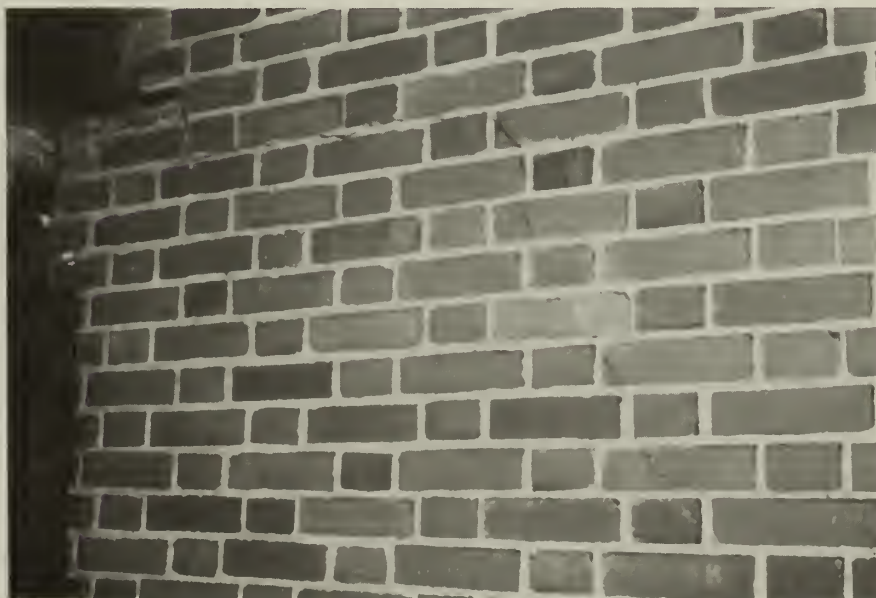
6. Crack on north elevation, near covered way 5.

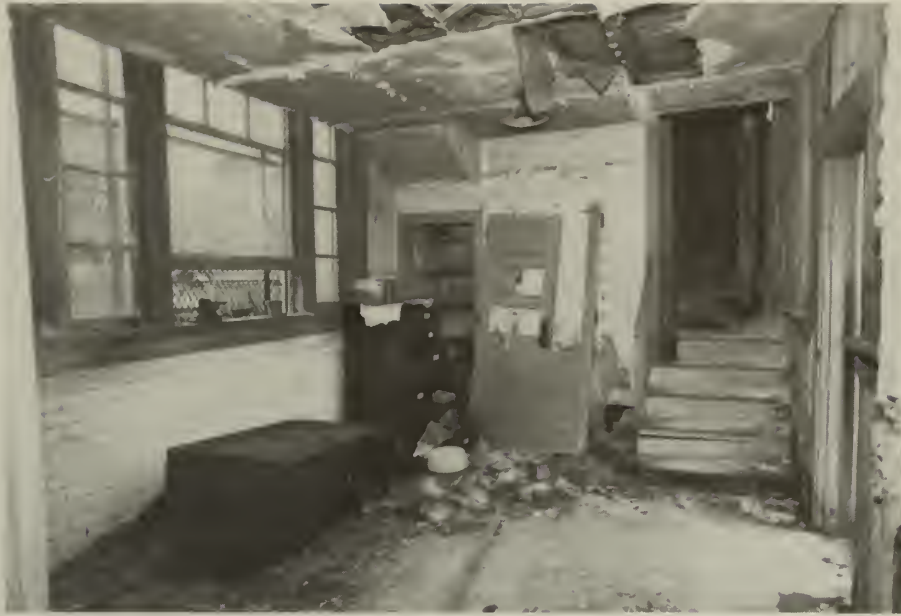
12. Room 104- lowered ceiling forming mezzanine level above. Deteriorated vinyl flooring revealing original hexagonal floor tile.

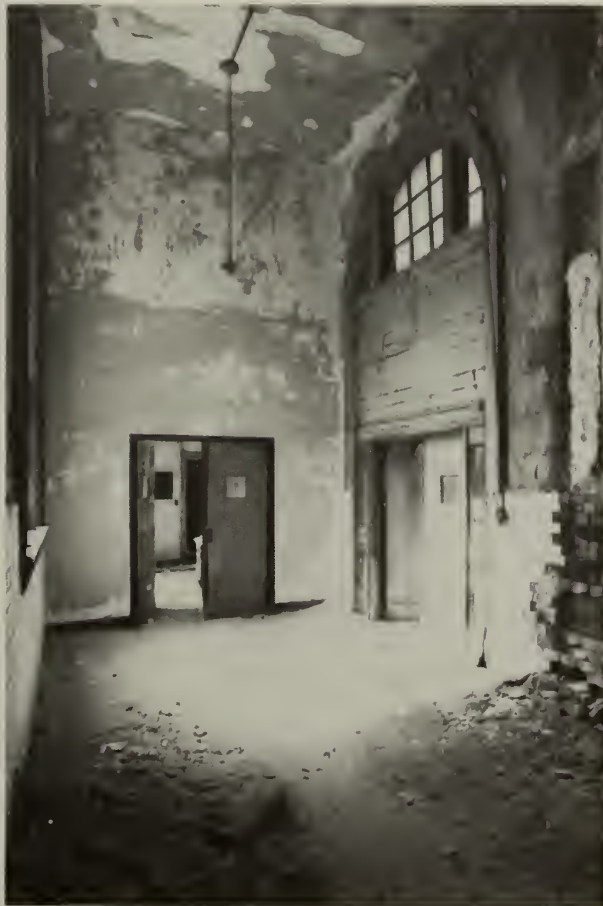
The overall condition of C-2 is poor, with sections of wall and ceiling plaster largely destroyed, exposing terra-cotta block and reinforced concrete ceilings (photo 13). The vinyl flooring on the mezzanine and first floor survives in a very deteriorated state. The wood platform erected over the ramp at the south end of the first floor has rotted through in several locations and presents an unsafe condition. Exhibits 6 and 7 depict the existing conditions of all floors.

13. Room 101- deterioration of plaster on wall at right and of ceiling parging.

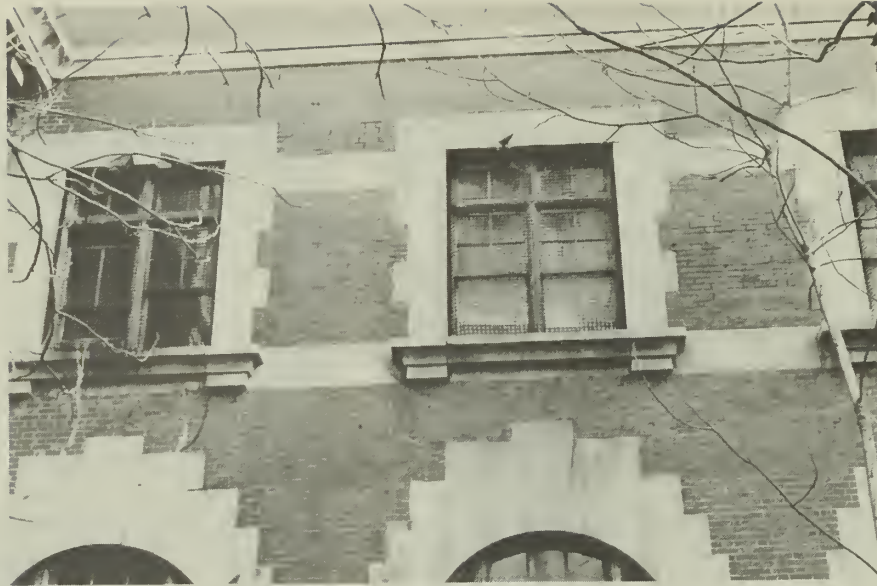
16. Cracking and spalling of stone on either side of keystones on the west facade of C-2.

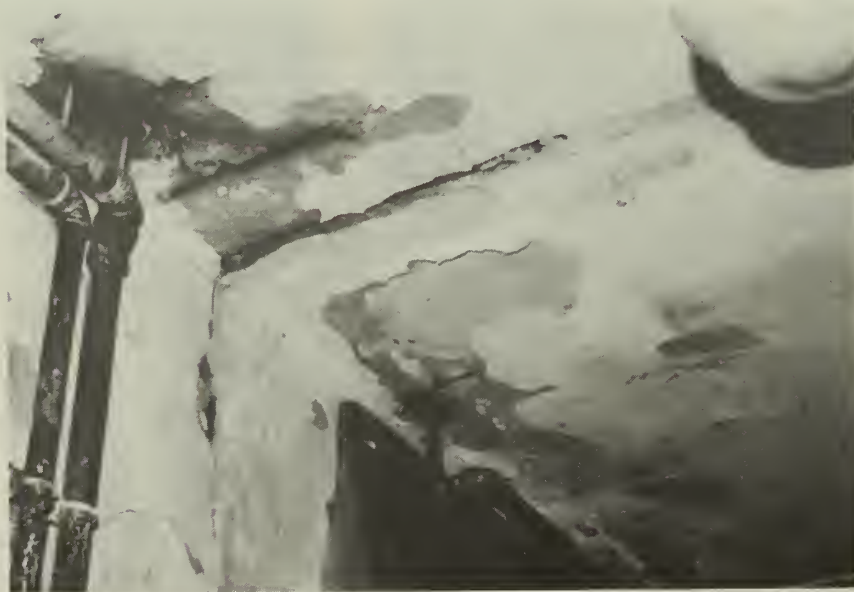
17. Severe transverse ceiling cracks and vertical wall cracks on second floor of C-2.

In addition to repairing the walls and roof, an expansion joint should be installed to remedy the cracking caused by thermal stress.

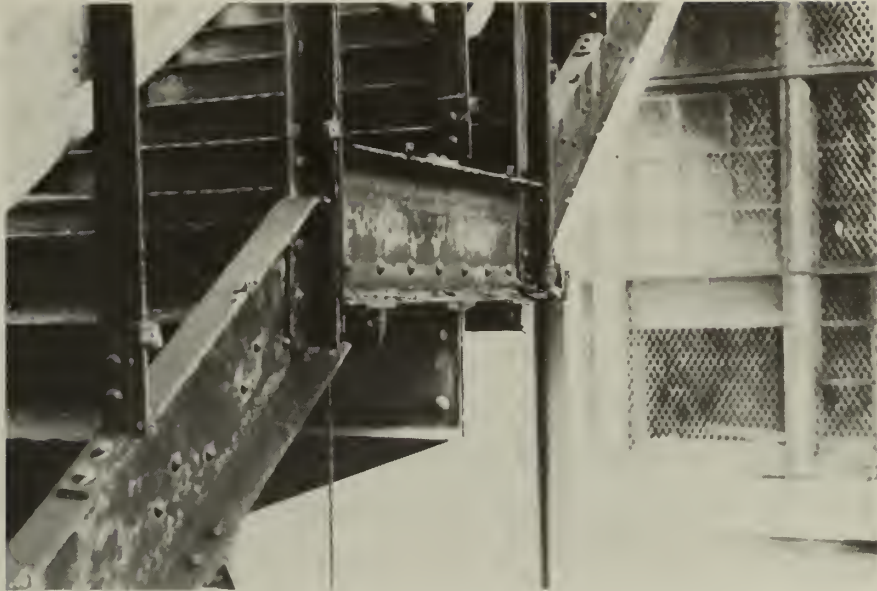
All steel elements are corroded and steel windows are severely deteriorated. The only serious corrosion is at the top of the bottom flange of the channel stringers at the intermediate platform.⁹ (photo 5). Most of the wire glass panes are cracked or broken and the skylight replacements merely lay over the existing copper roofing. The top right-hand section of the 2-1/4" oak double handrails is missing over the first run.

5. Corrosion on top of bottom flange of channel stringers at intermediate platform.

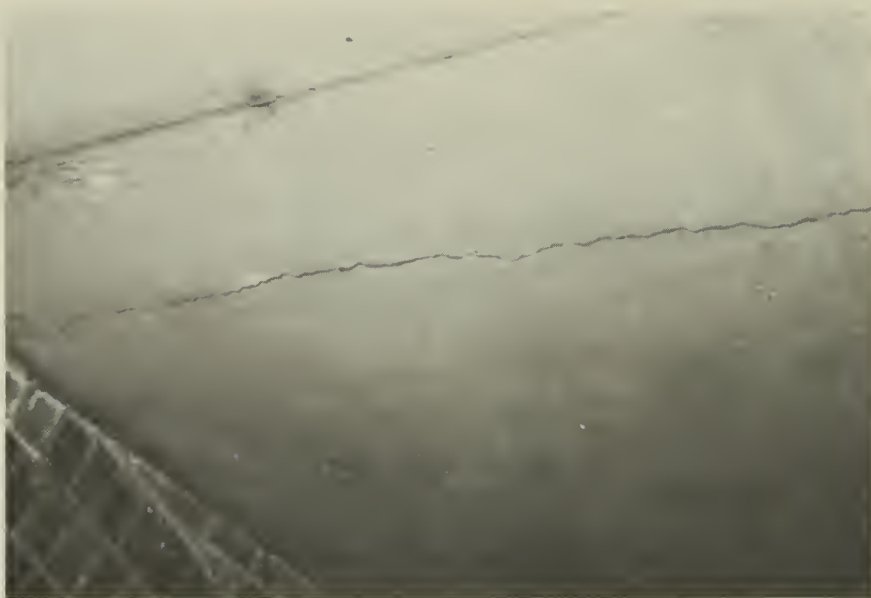
A crack in the soffit of the brick arch is located at the western end of the passage where it joins C-5. The ceiling slab has many transverse cracks with evidence of some water leakage (photo 7). Near the entry to the baggage and dormitory building there is severe cracking of the brick walls at both east and west sides (photo 8). Both types of cracking are caused by temperature related movement. The brick infill of one of the west arches has a wide vertical crack where the wall is bulging inward. The cracking of the support walls at both ends of the arcade are acting as expansion joints. Expansion joint material should be placed in these cracks to forestall water intrusion. Plants are growing in the gutters.

7. C-4- transverse cracks in the ceiling with evidence of water leakage.

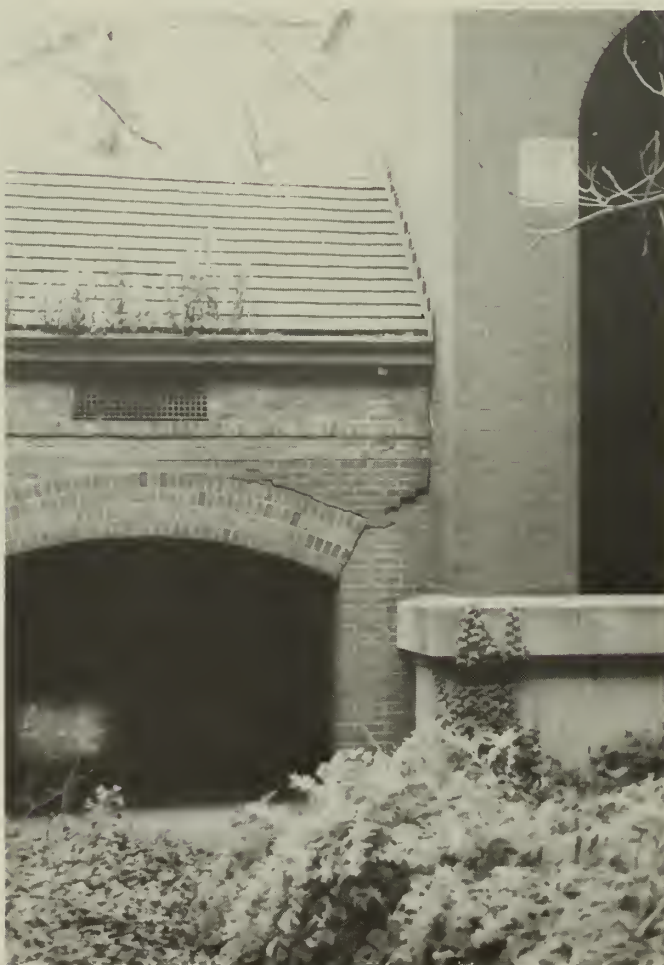
8. C-4- separation at mortar joints on east wall near arched pavilion to baggage and dormitory building.

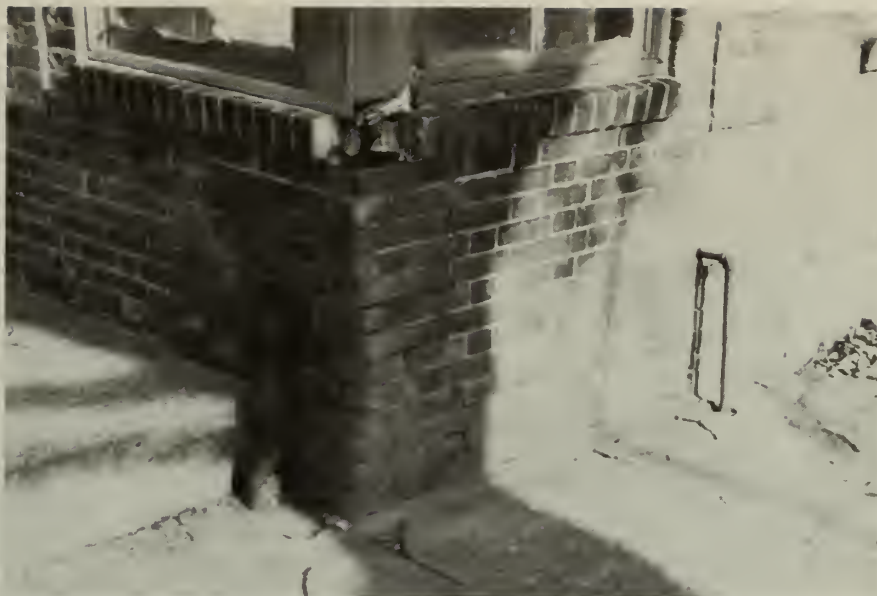
11. Missing brick at corner of window sill, northeast pavilion.

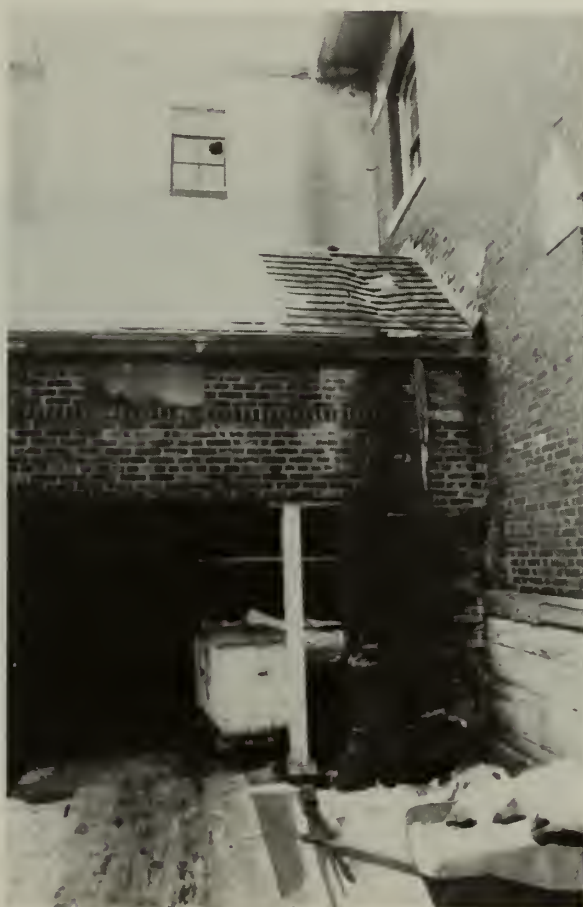
12. Crumbling brick and temporary wood support, east elevation of C-5 adjacent to powerhouse, view west.

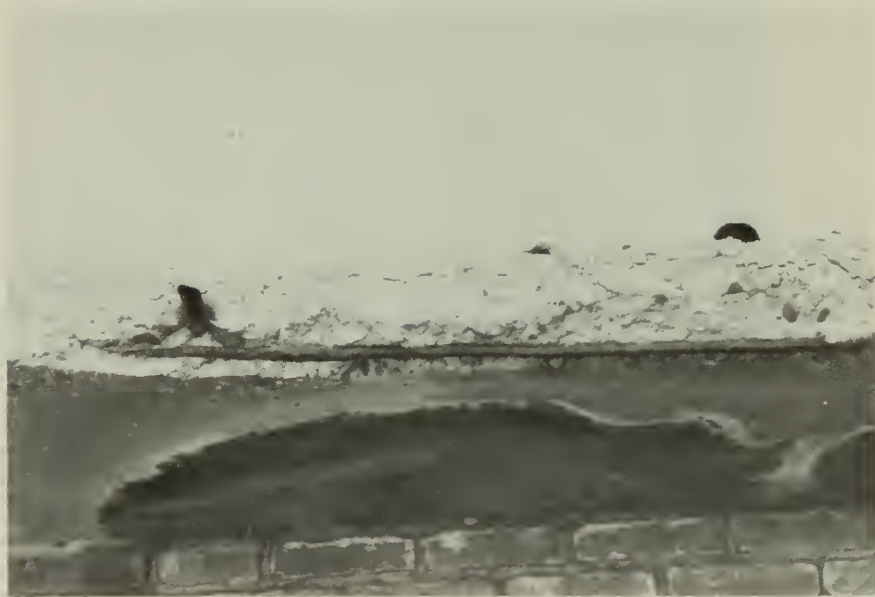
13. Exposed corroding beam causing concrete spalling, lintel on gabled projection.

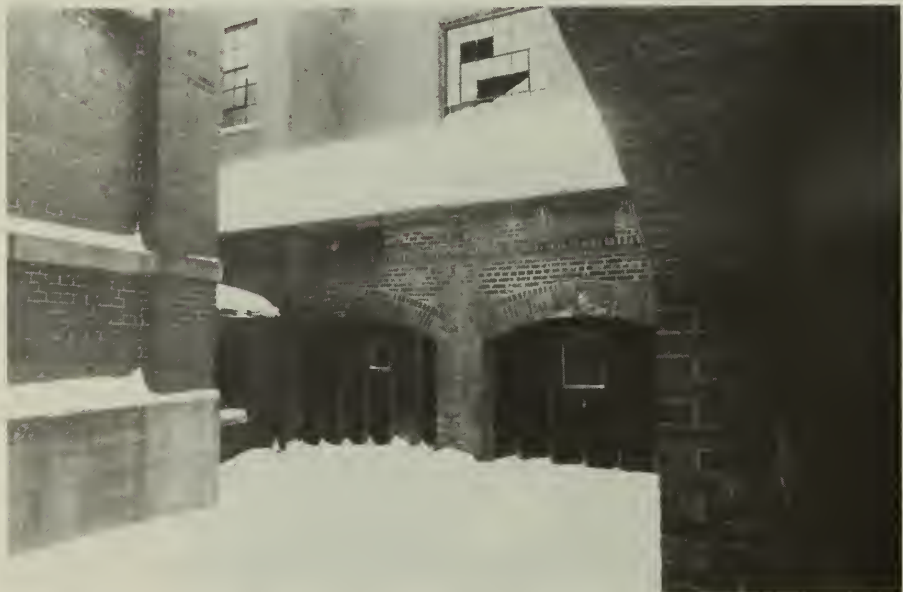
14. Two arches at the northern end of east elevation; filled in with wood supports and tar paper; view southwest.

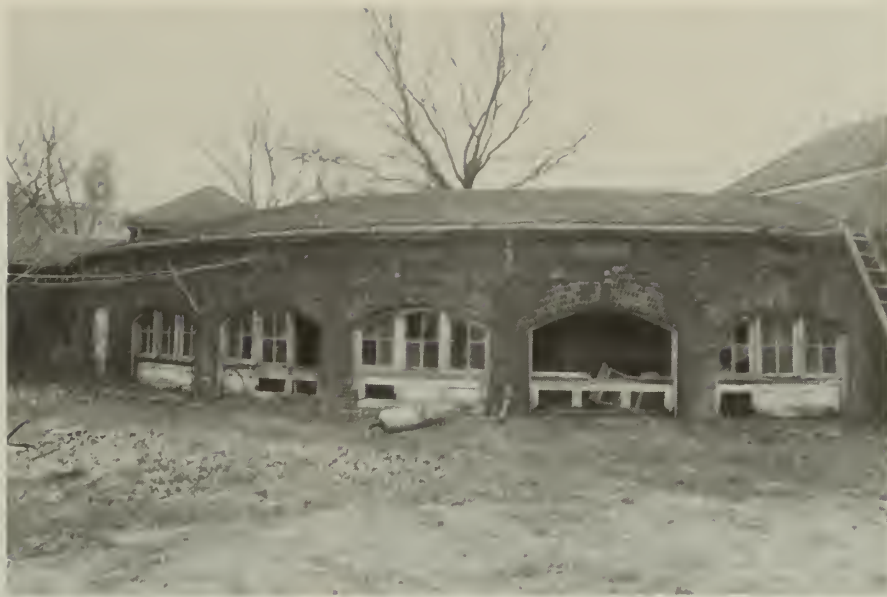
15. Rotting, broken, and missing windows and wood panels, west elevation.

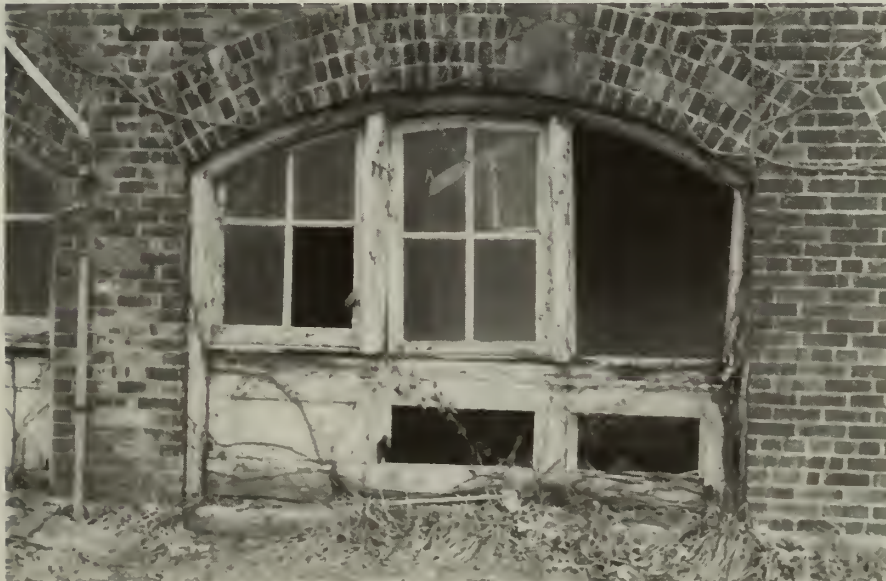
16. Rotting, broken, and missing window, west elevation.

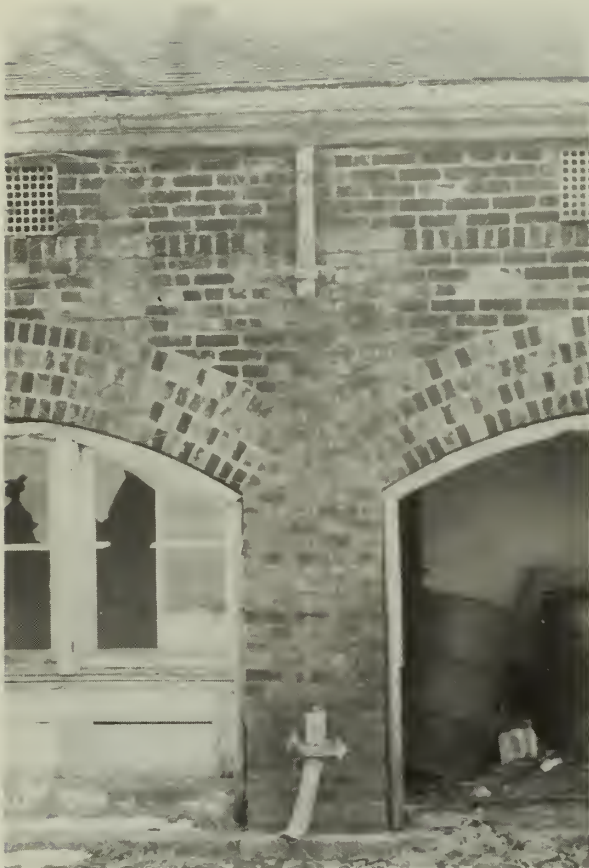
17. Missing section of downspout, west elevation.

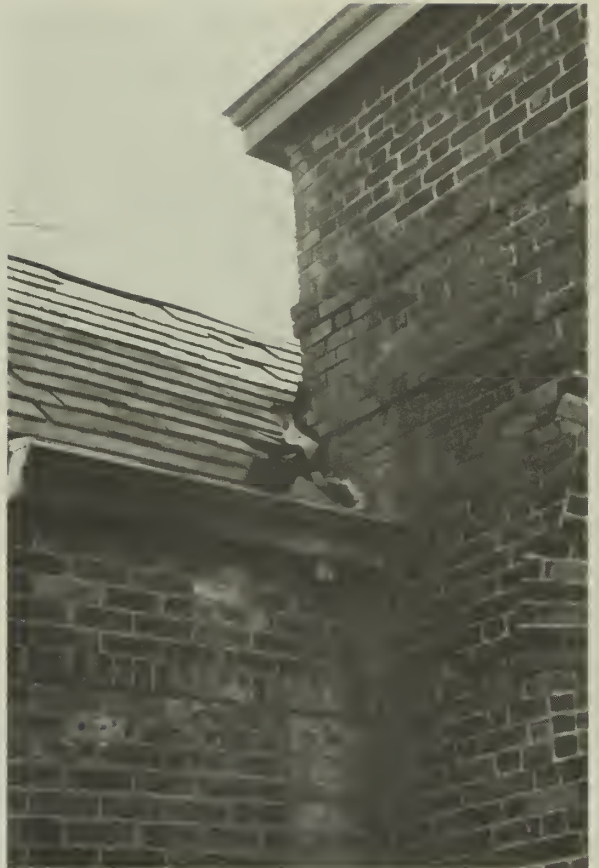
18. Torn flashing at juncture of gabled projection and pavilion, west elevation.

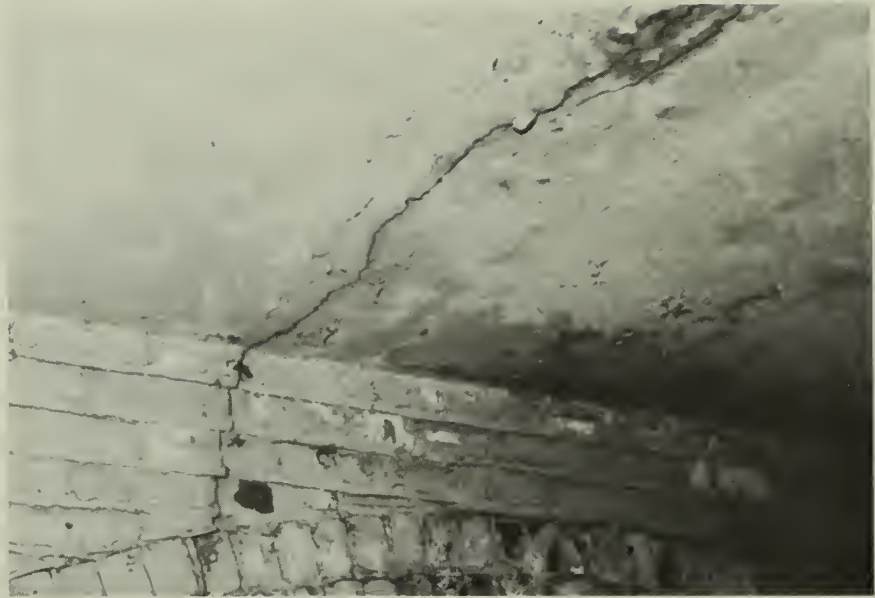
24. C-5- transverse ceiling slab cracks.

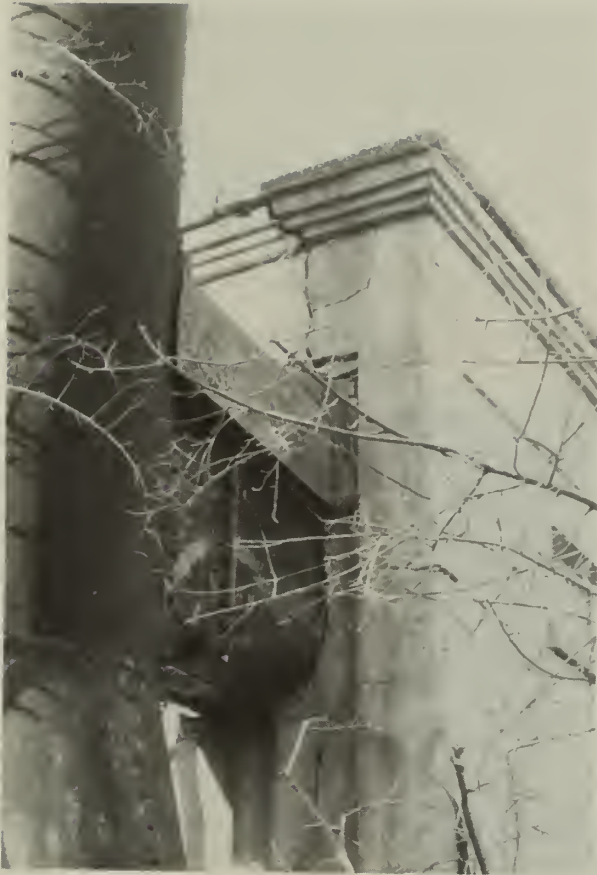
7. Cracking and spalling at east elevation, adjacent to smokestack.

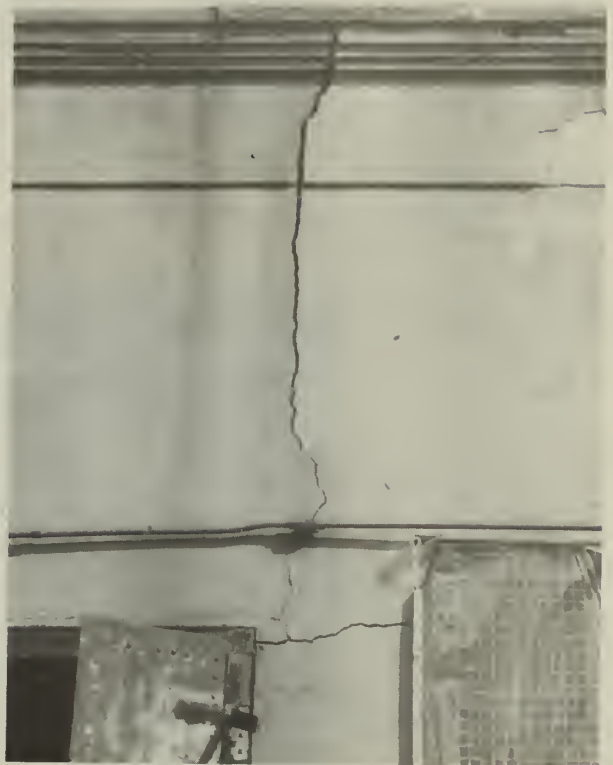
8. Severe cracking, south elevation.

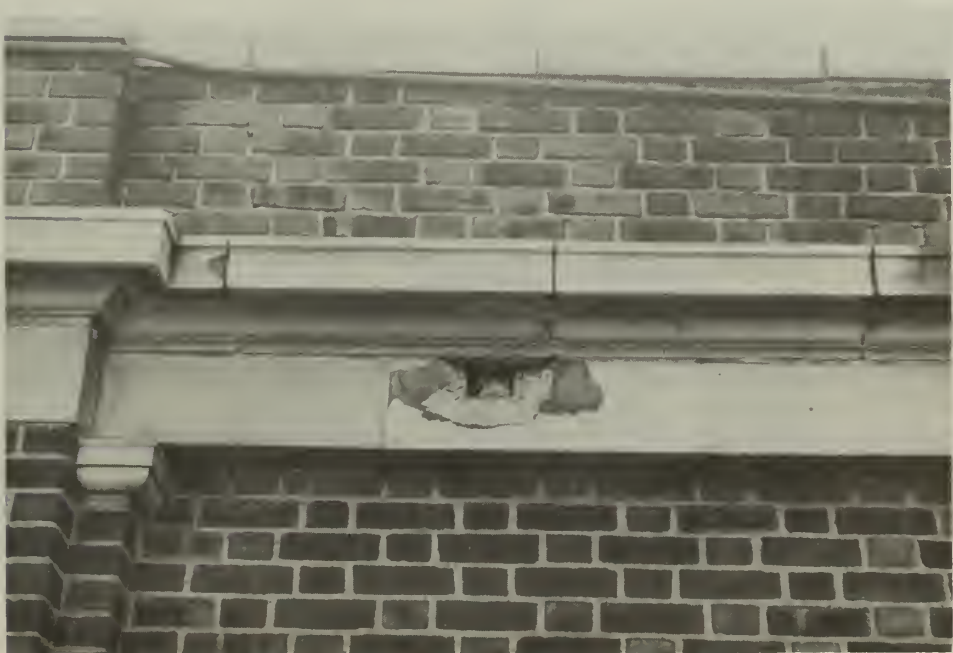
7. Hole and spalling, west elevation.

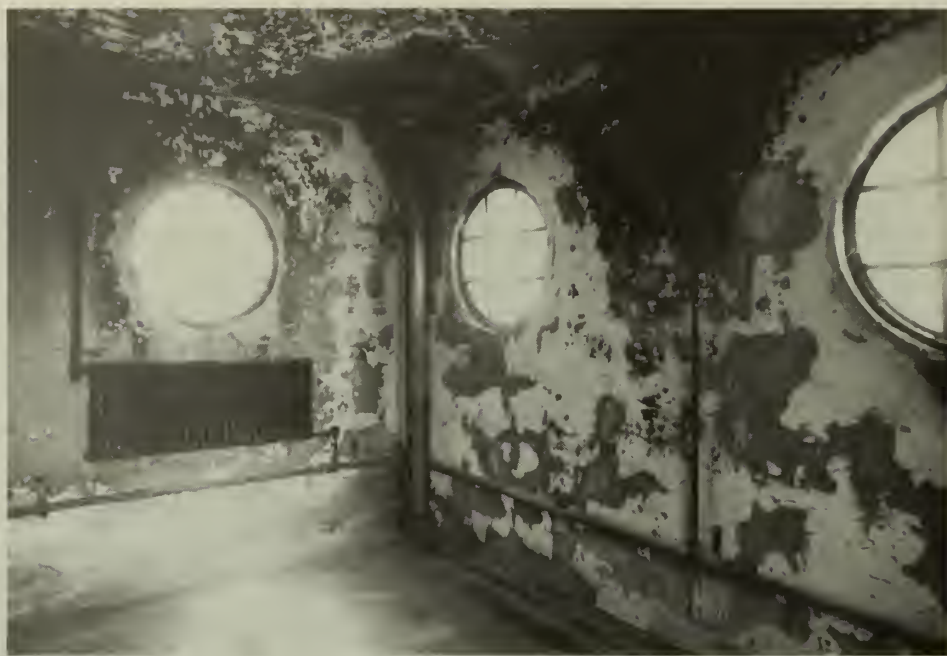
8. Room 103- view of northwest corner, exposed terra-cotta on walls and ceiling lath. 139
